Wells County Public Library Air Leakage Inspection Report

Building: Wells County Public Library

Submittal Date: February 2, 2021 - REV.

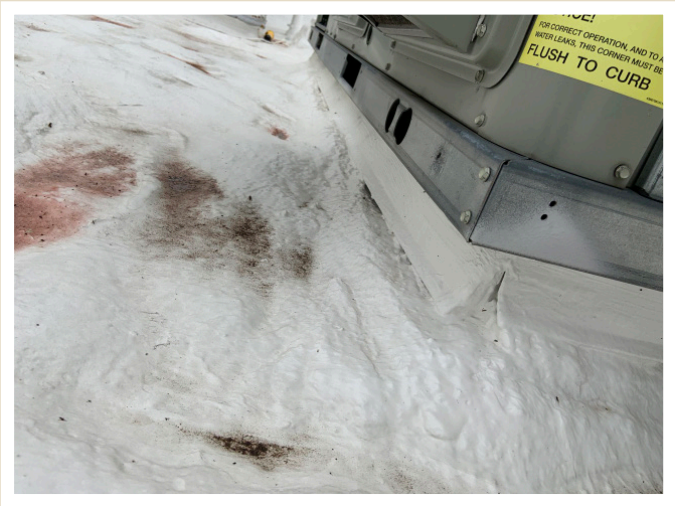
- A. Typical roof equipment curb that allowed for uncontrolled air leakage to occur from the conditioned space. Sealing the curb flashing to curb is required.
- B. Typical powered roof top exhaust. These are often very leaky and can have stuck dampers that allow for continuous venting. Inspecting and sealing the units is recommended.

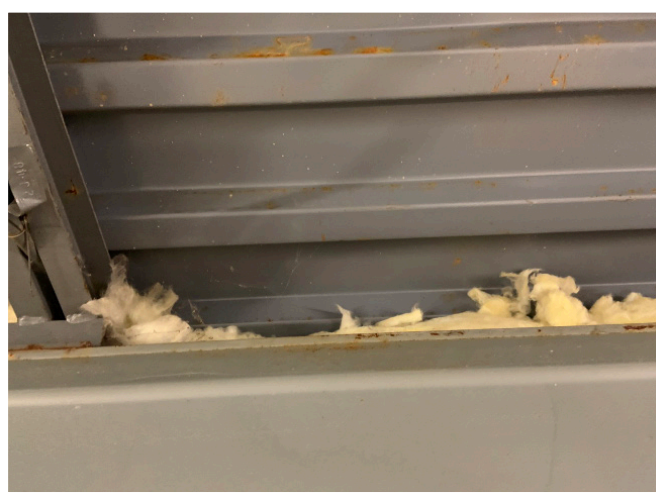
- C. Fiberglass insulation at the roof/wall intersection was not an effective air barrier. Cobwebs are good indicators of air leakage at these joints.
- D. More fiberglass insulation at the roof/wall intersection. This does not stop the exchange of air between interior and the exterior resulting in higher energy consumption

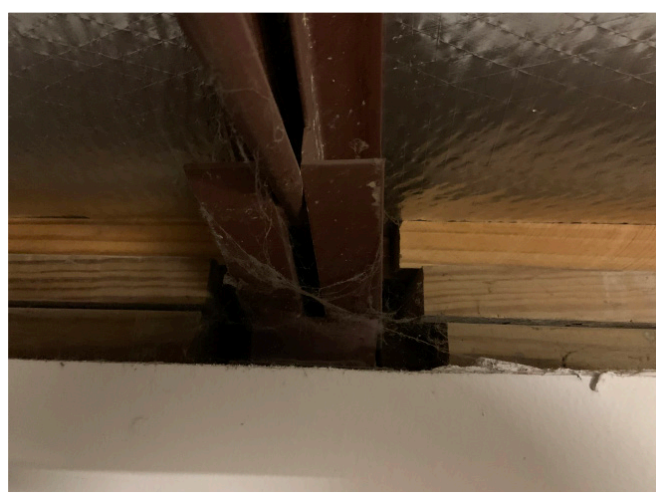
- E. The truss penetrations through the roof/wall intersection showed visible signs of air leakage via the cobwebs. Sealing this along with the leaky joints in the wood blocking materials is recommended.
- F. Having a leaf on the interior at this transition was a good indicator that there was a joint where outside air can freely enter into the building. Sealing this joint is recommended.

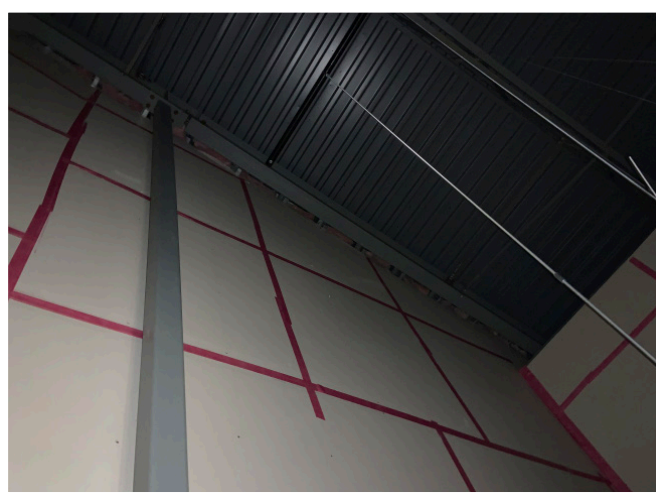
- G. The drywall joints had been sealed, however, the vapor barrier was not connected. Air leakage was still occurring at the roof/wall intersection. The height at this location may restrict safe access and prohibit sealing this transition.

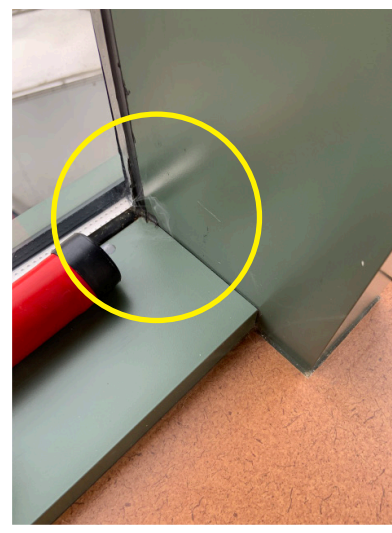
- H. Air leakage detector shows smoke drawn into the window frame. This was an indicator of uncontrolled air leakage and energy losses. Sealing the mullion joints will reduce energy losses.
- I. The joint between the wall and the windows was also an area that required new sealant, as conditioned air was escaping and outside air could enter the building.

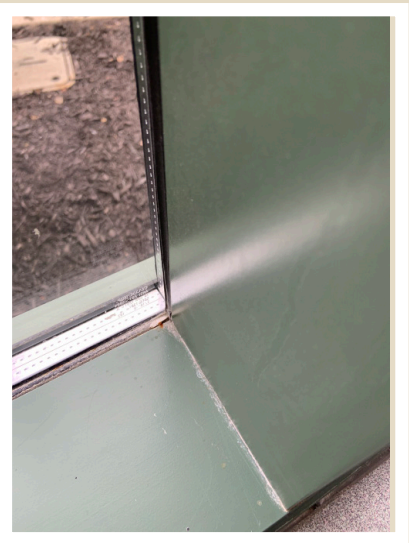
- J. Cleaning and sealing the mitre joints as well as the corners of the windows will further reduce the uncontrolled air leakage at the Library.

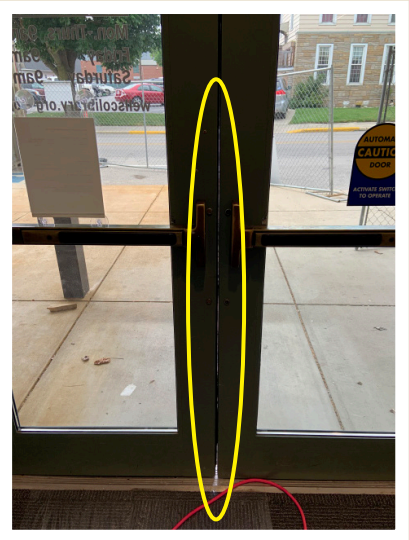
- K. Daylight was visible between the double commercial doors. Replacing the existing seals is recommended to reduce uncontrolled air leakage and energy losses.
- L. Existing brush seals at exterior doors were in poor condition and allowed for air leakage to occur. Installing vinyl clad compression seals to the steel exterior doors is recommended.

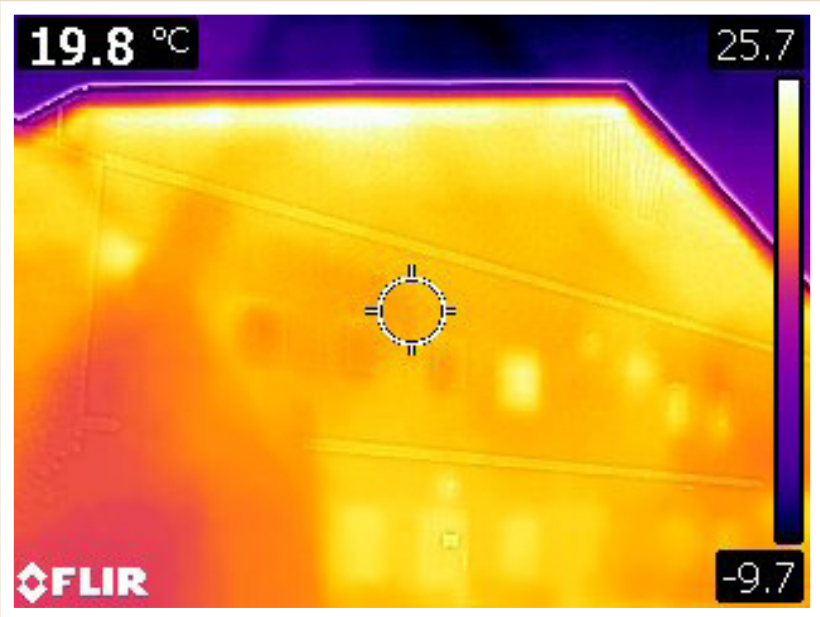
- IR-A. The brighter color at the soffit of the gable end indicates heat escaping the building at the roof/wall intersestion. The lack of continuous air barrier at the top of the wall will result in heat losses.
- IR-B. The brighter yellow at the door perimeter indicates some heat loss was occurring between the operable door and frame. New weather-seals would reduce the air leakage.

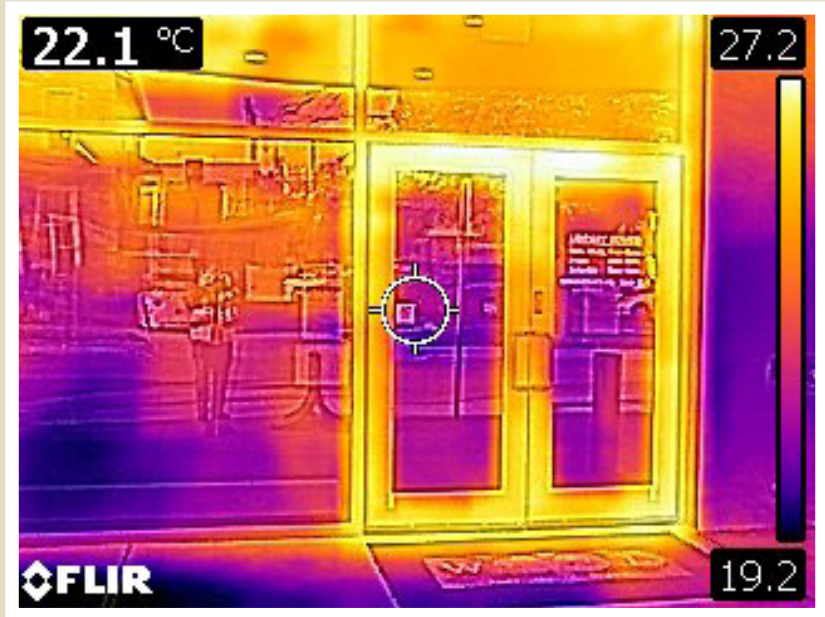
IR-C. Heat loss was occurring in two ways at these doors; the larger being thermal bridging. Air leakage could also be contributing to the warmer metal door, as the conditioned air passes around the operable door.
